John Lewis Building Condition Assessment

Sheffield City Council

Summary Report

November 2021 Rev A

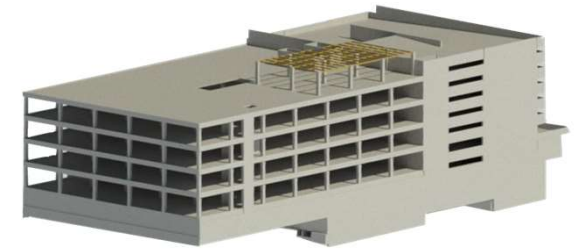
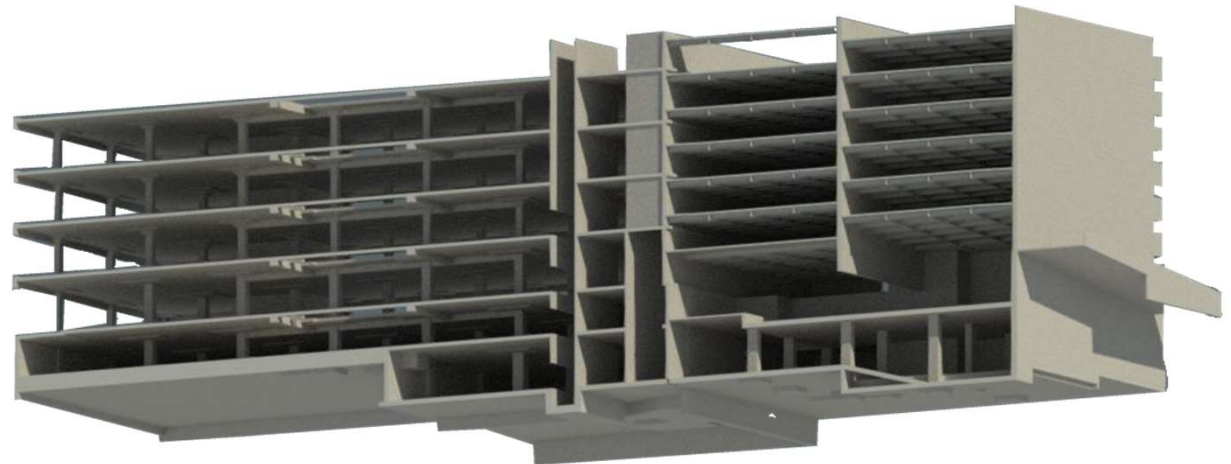
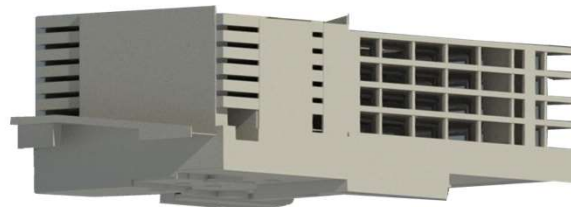
The concrete frame of the main store could not be immediately inspected due to the presence of the interior fit out and the extensive asbestos issues in the finishes.

Therefore the condition of the structure of the main store is difficult to assess due to restricted access to the site and existing finishes/coverings.

However, the limited exposed areas of structure witnessed during our inspections are in a reasonable condition, and we would expect the structure to be reusable as part of an extensive refurbishment of the building –noting the limited nature of the visual survey. Further intrusive investigations would be needed if this option is to be pursued.

There will inevitably be some issues with this frame, particularly on the roof level due to failures in the roof finishes and having RWP's embedded in some of the columns.

Once the building is stripped out and available for inspection then the concrete frame can be closely inspected for any signs of deterioration and damage.

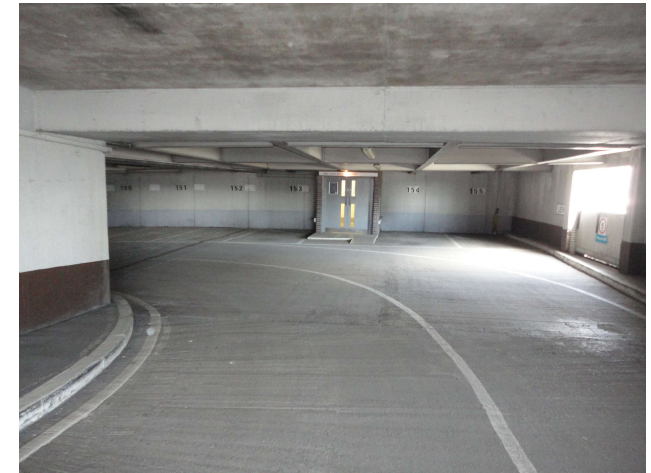
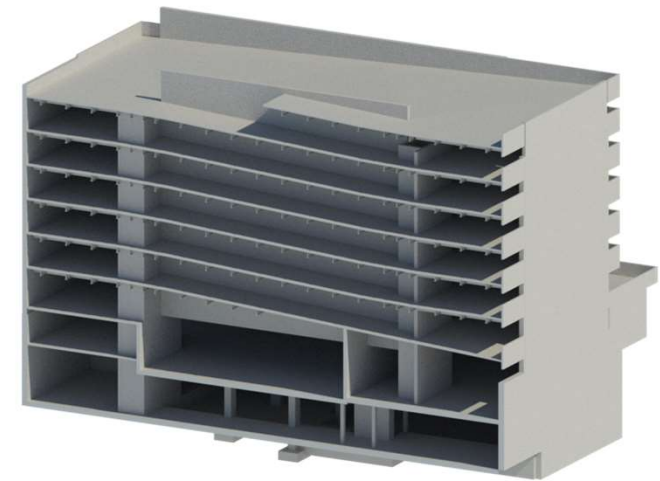
The car park is in a much poorer condition than the main store and there are numerous elements of cracking and spalling of the concrete. The steel beams have areas of corrosion that has removed the corrosion protection and also the intumescent paint that provides the fire protection to the structure.

The de-icing salts used over the years have corroded the concrete structure. The chloride ingress has resulted in significant areas of deterioration. Significant repair works and maintenance would be required over the next 25 years

Due to a change in the chemical composition of HAC concrete, through a process called conversion, these prestressed beams can lose up to 50% of their intended structural capacity.

The lower levels of the car park have been retained in their original form of precast prestressed HAC concrete beams but these have been strengthened by the addition of steel beams and columns to mitigate the issues.

The car park is not in good condition and would require significant repair and ongoing maintenance over a 25 year period. In conjunction with reducing car parking demand with John Lewis vacating, we would recommend that serious consideration is given to demolition of the car park in any redevelopment option.

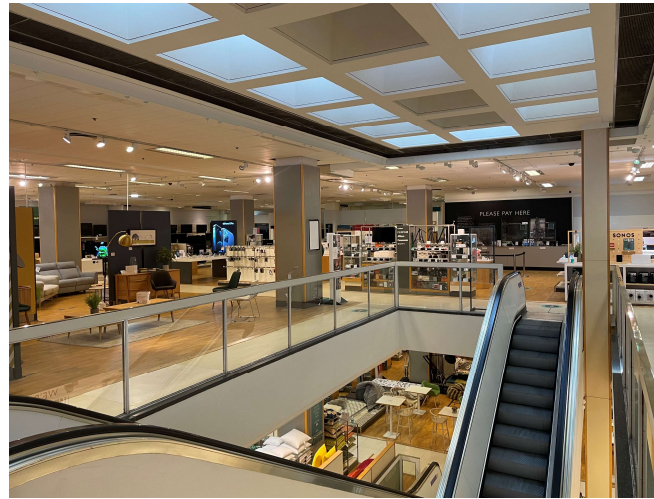
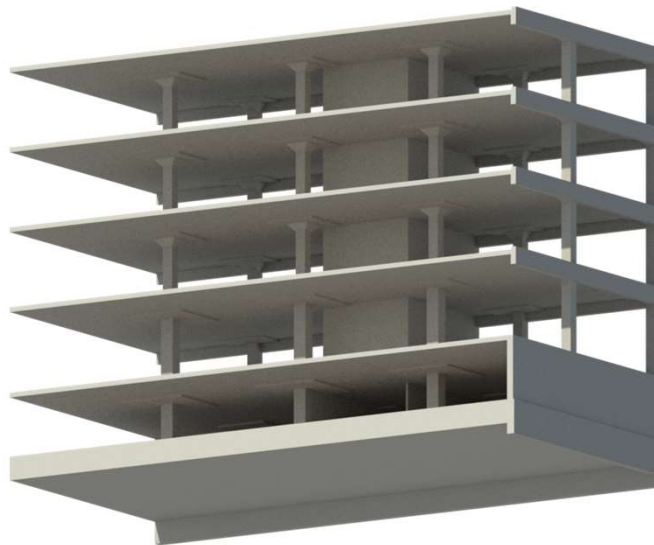
The building is not fully protected by an automatic fire detection and alarm system, which would be normal current practice for any similarly sized building. A sprinkler system exists, which is fed directly from the mains water system (with a dedicated booster pump); this would not be compliant with current practice.

The lighting system is inefficient and no longer suitable for continued use, even in a retail situation.

It is therefore recommended that any refurbishment or repurposing of the building includes a full strip out of all ceilings, non-structural partitions, services distribution (wiring containment, ductwork, pipework), MEP plant and equipment, taking care to remove and dispose of all asbestos containing materials (ACMs). This will create a clear canvas for new, efficient systems to suit the new purpose.

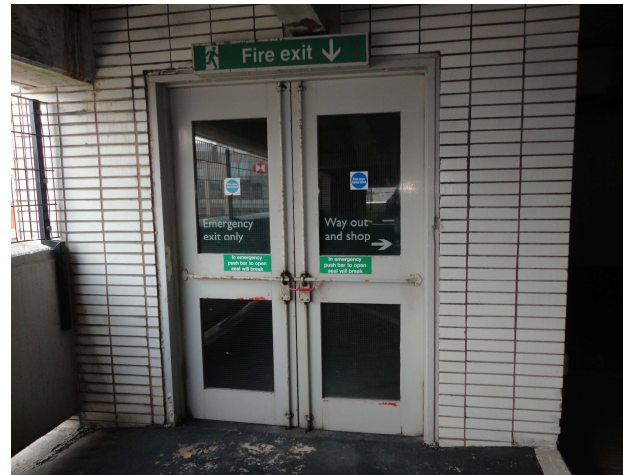
Structural beams were observed to have cementitious/vermiculite type fire protection boards of varying thickness in the back of house and plant areas. It would be reasonable to assume that this would be likely to provide at least 60 minutes fire resistance. However, areas were observed where this protection was either damaged or missing.

- The level of fire protection to the building structure is unknown. In some areas damage has occurred to the fire protection of the structure and needs remediation.
