**REPORT TO CITY CENTRE SOUTH &  
EAST AREA PLANNING & HIGHWAYS  
COMMITTEE**

SUBJECT 20A CLARKEHOUSE ROAD, SHEFFIELD, S10 2LB

### ENFORCEMENT REPORT

#### UNAUTHORISED DEMOLITION OF PORTIONS OF BOUNDARY WALL ADJOINED TO A LISTED BUILDING AT 20A CLARKEHOUSE ROAD, SHEFFIELD, S10 2LB

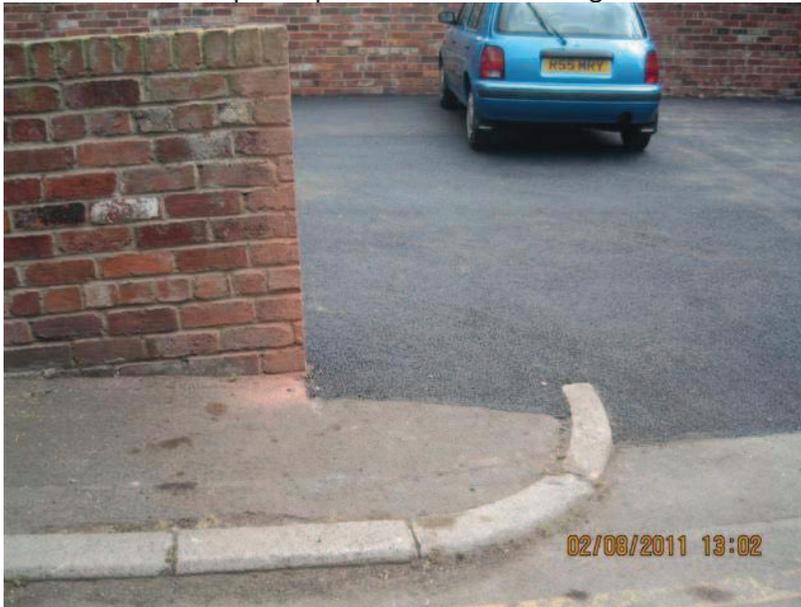
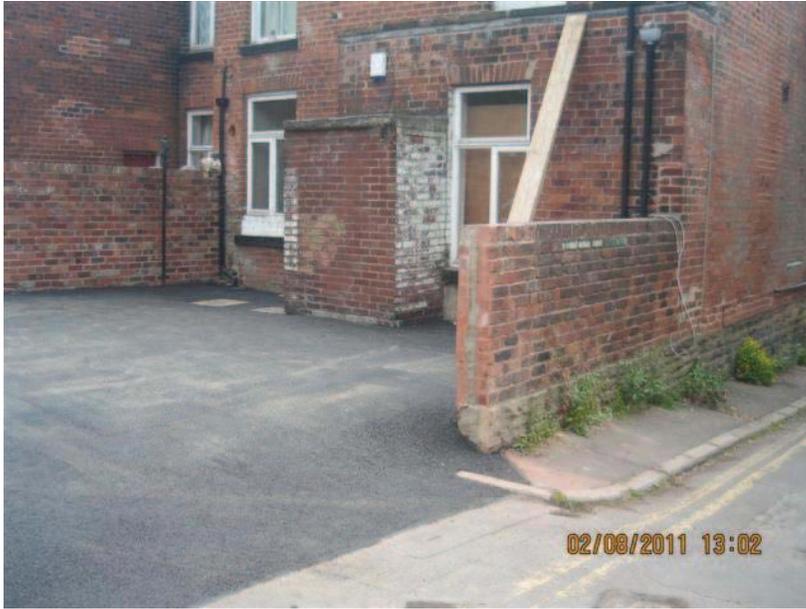
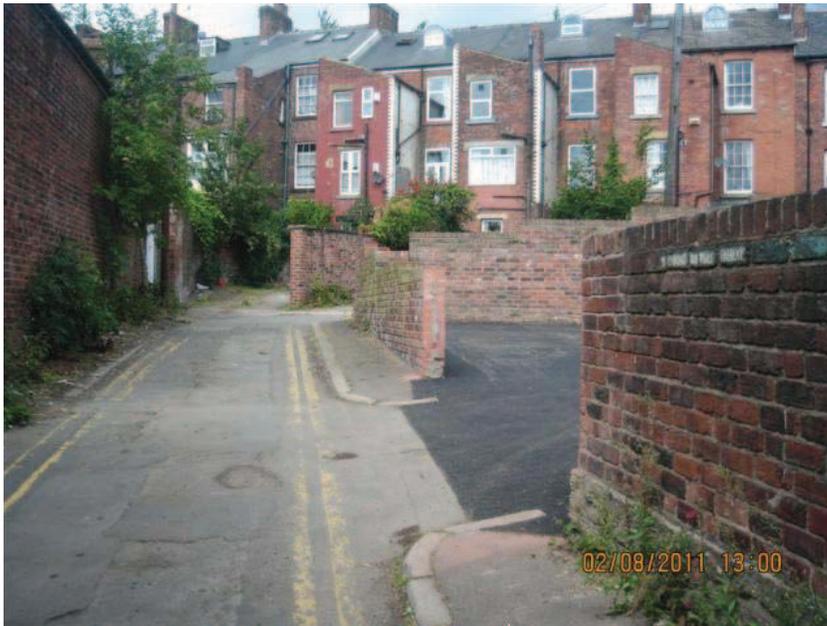
- 3.1 The access opening as it previously existed featured a short stone portion close to ground level on the right hand side of the opening and brickwork that was reasonably well detailed at the termination points. The amended opening simply involves the 'slicing off' of two lengths of the wall.

- 3.7 The removal of the portions of boundary wall has been done rather crudely, and is considered to have a detrimental impact upon the appearance and character of the listed building. The wall acts to enclose the curtilage to the listed building, and is therefore considered to represent a key part of its character. The brick work has been cut through in a manner unsympathetic to the listed building, and pays no regard to the historic significance of the building or its contribution to the character of the area. Overall, the works are considered to fail to comply with the aims of policies BE16, BE17 and BE19.

- 3.7 The widened access is shown in the below photographs, illustrating the harmful impact upon the listed building:

- 3.11 As covered above the Owner has indicated that the works are due to be completed by the end of May 2012. A Listed Building Enforcement Notice would then be issued if this deadline was not achieved. The Listed Building Enforcement Notice would require the reinstatement of the two portions of wall either side of the access. This would be required to be carried out using matching stone and bricks, providing brick column type additions.

- 8.1 That the Director of Development Services or Head of Planning be authorised to take all necessary steps, if needed, enforcement action and the institution of legal proceedings to secure the re-instatement of the demolished portions of wall, using suitable materials and finished in an appropriate manner.
