Appendix of Photographs

Staniforth Road – Examples

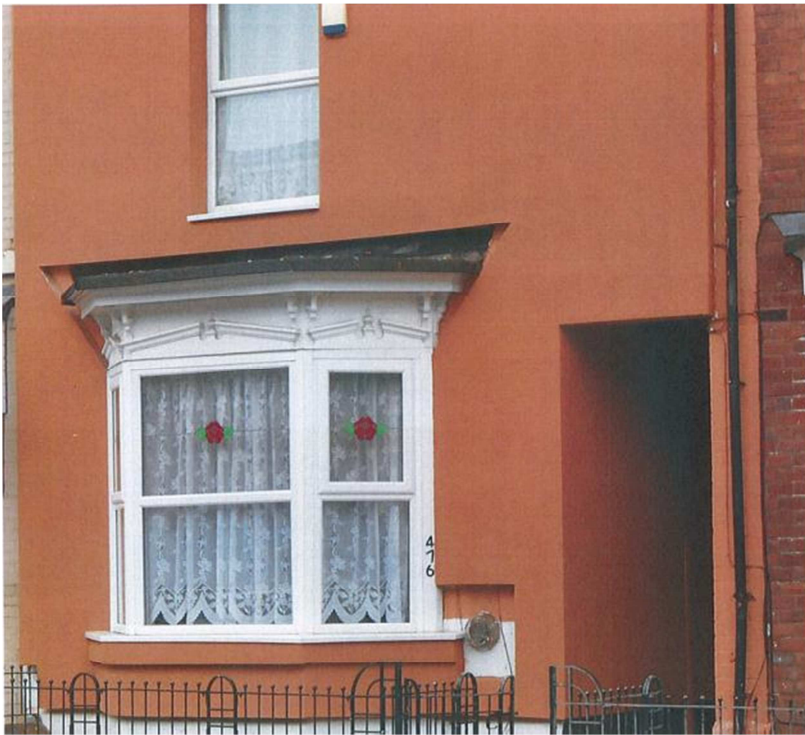
Example of EWI on Staniforth Road, which is typical of the installations in this road.

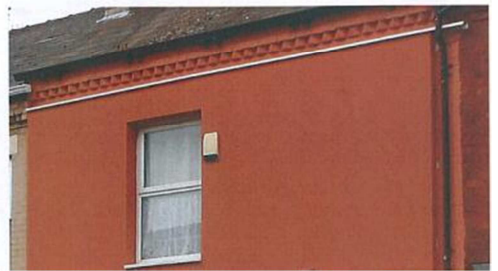
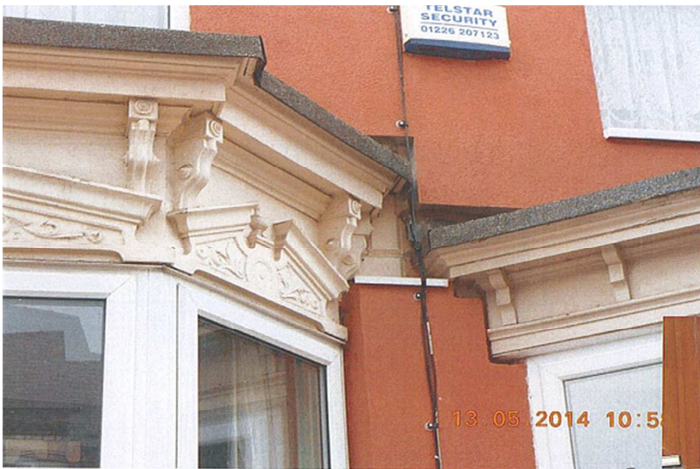
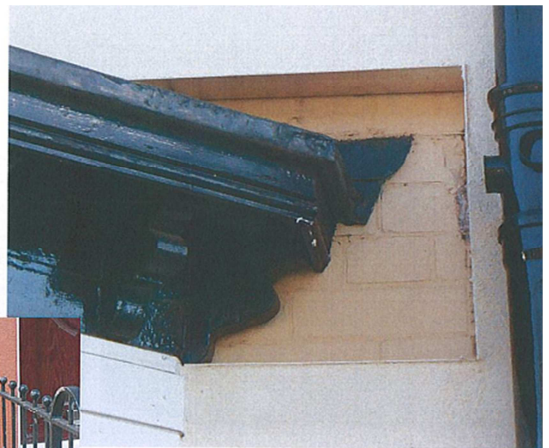
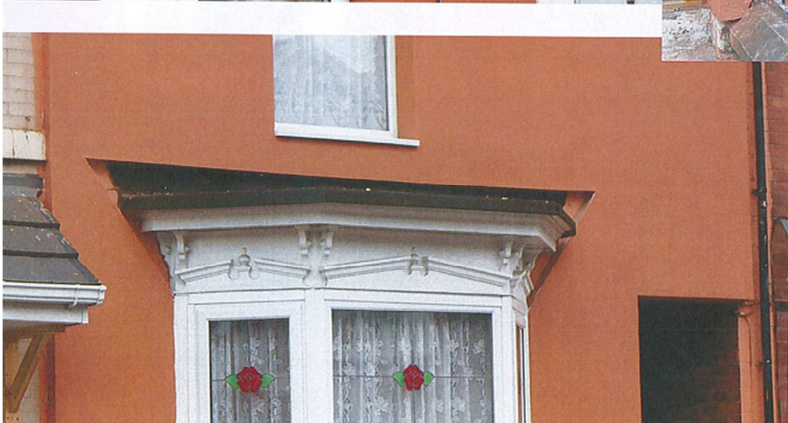
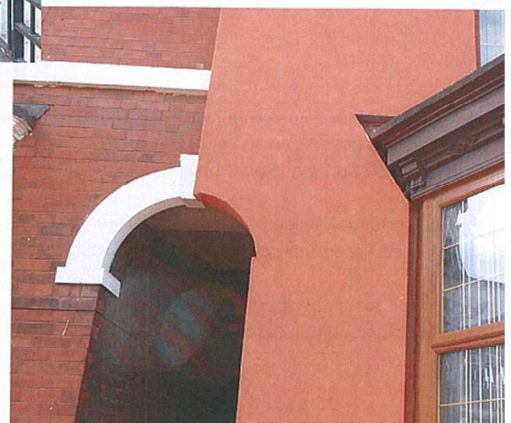
Sill & head stones lost to 1st floor window
Stone Head over passageway lost (previously painted red)

Brick coursing detail lost (previously painted red)
Clumsy boxing around boiler vent and bay roof.

Paint overspill onto neighbouring house to disguise awkward box finish next to passage entrance. Also capping plastic clumsily left overhanging neighbouring house.

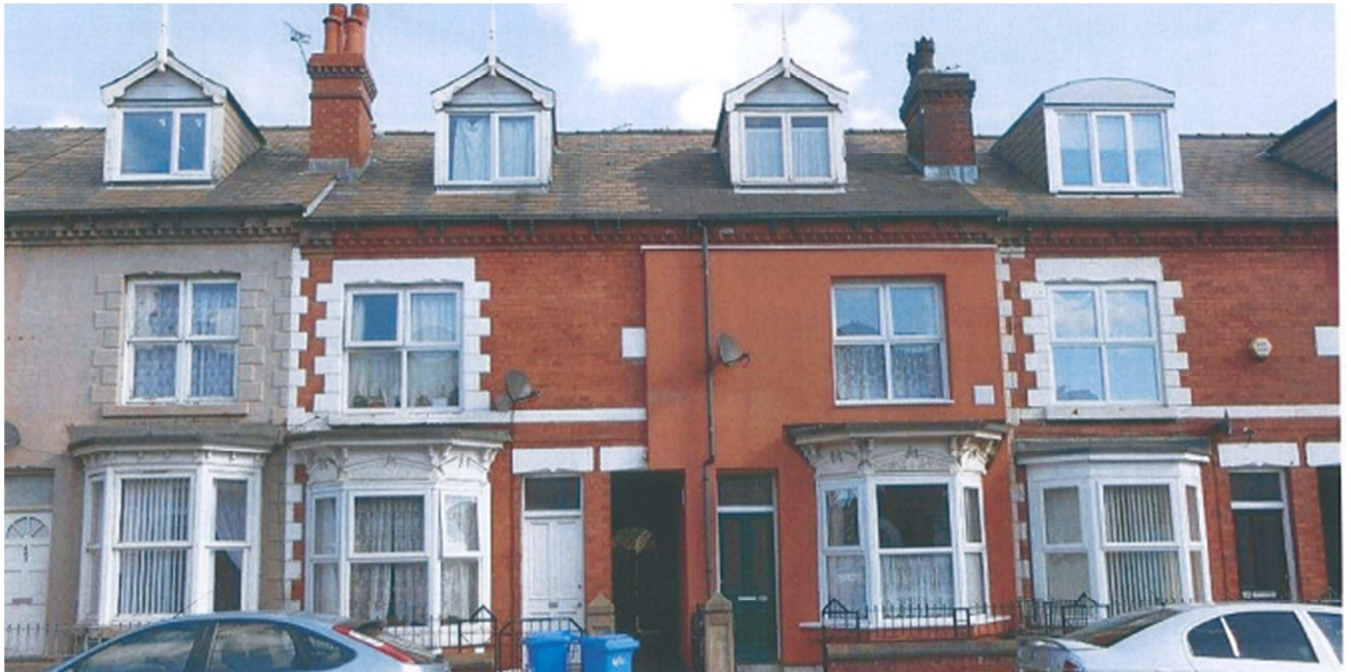
Staniforth Road – Shows contrast between EWI and traditional design but also shows how some houses were painted in the past.

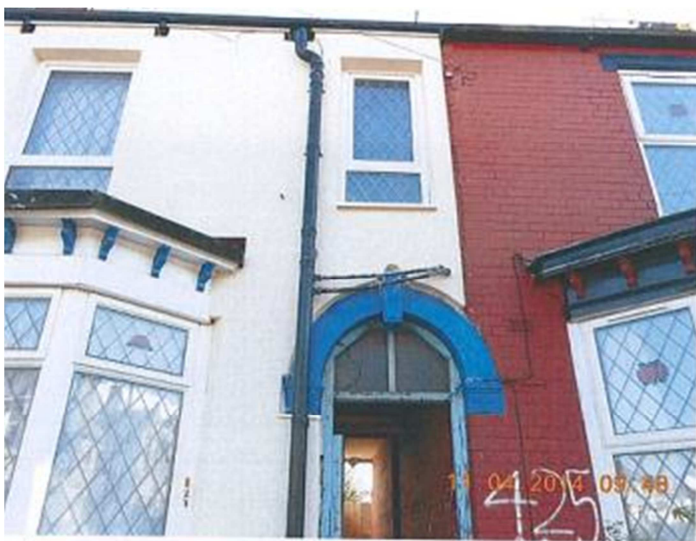
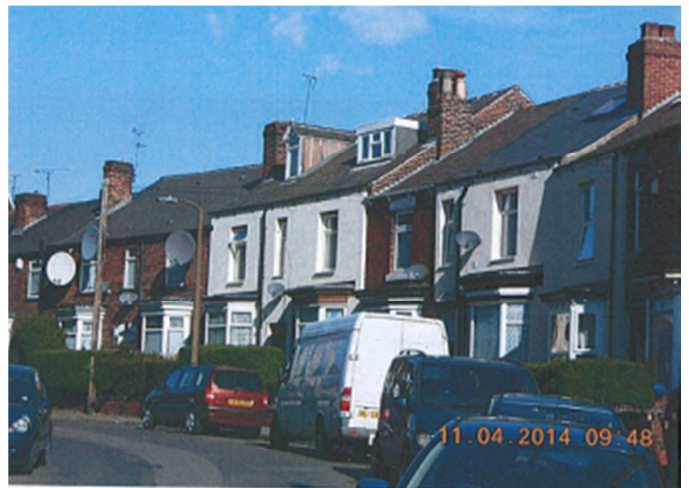
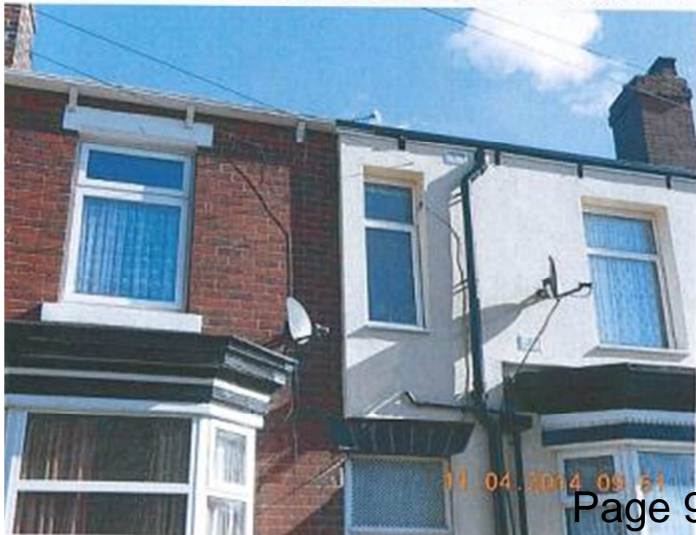
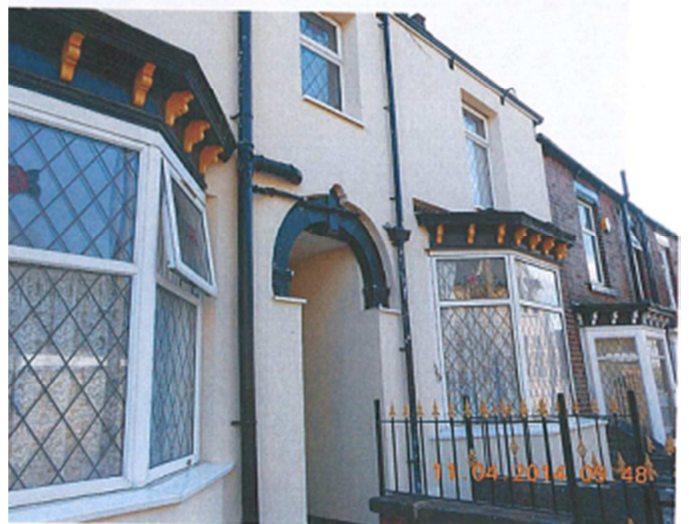
Earl Marshal Road (below)

Shows contrast between traditional red brick and cream smooth render. Some Heads / Sills lost.
