BELLHOUSE ROAD, SHIREGREEN PROPOSED ZEBRA CROSSING

ROAD SAFETY AUDIT STAGE 1 [PRELIMINARY DESIGN]

**DEVELOPMENT SERVICES
TRANSPORT, TRAFFIC & PARKING SERVICES – ROAD SAFETY**
Safety Audit Ref: TE/16-591/LT1976/ST1
Date: 19th January 2017

STAGE 1 ROAD SAFETY AUDIT REPORT [PRELIMINARY DESIGN]

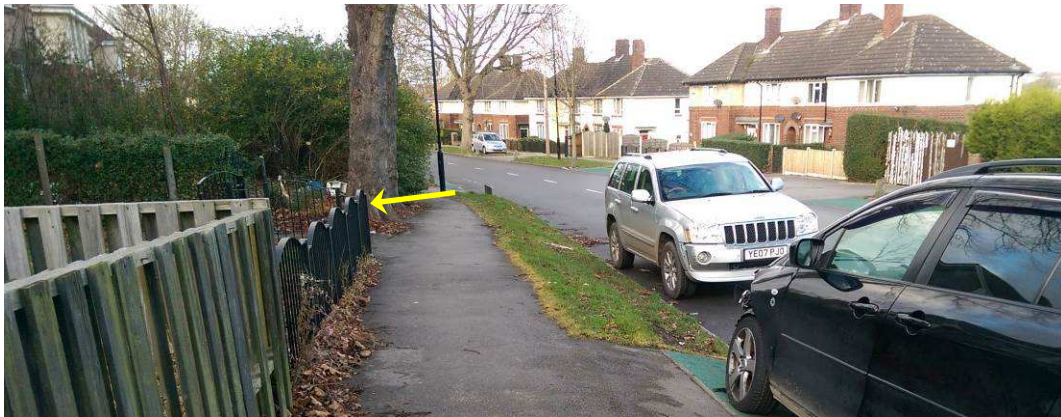
Summary: Significant level difference across verge

It is proposed to relocate the Bellhouse Road northbound bus-stop into Beck Lane, to the above position. The drawing provided shows a strip of guidance paving running straight across the verge and footway, up to the new stop.

During the site visit it was noted there is a significant level difference across the verge in this location, as it falls towards the carriageway from the front of the footway. See photo;

It will not be possible to construct the paved strip as indicated due to the severe gradient. In order to provide passenger access between the footway and bus-stop, significant civils works will be required. There will be a need for the provision of ramps and steps, as a minimum.

There is also ongoing restoration work at the adjacent property. In the location indicated by the arrow in the above photograph, there is a gap in the fence at the front of the property. The property owner may be intending to use this area for driveway access to the property.

The Team will need to consider these issues during detailed design, to ensure that the chosen location is viable. An alternative proposal may be required.

The design team have measured the level difference on the topographical survey and confirm that there is approximately 30cm – 40cm difference from back of footway to the front of the verge. Given the width of the footway/verge is 3.4 metres by raising the front with a bus border kerb to 200mm the fall will be approximately 7-8% or 1 in 20. Further details will be provided at RSA stage 2. If the property owner did decide to apply for an access this could be to one side of the bus stop. The drive would be blocked if a bus were to be stationary at the stop.

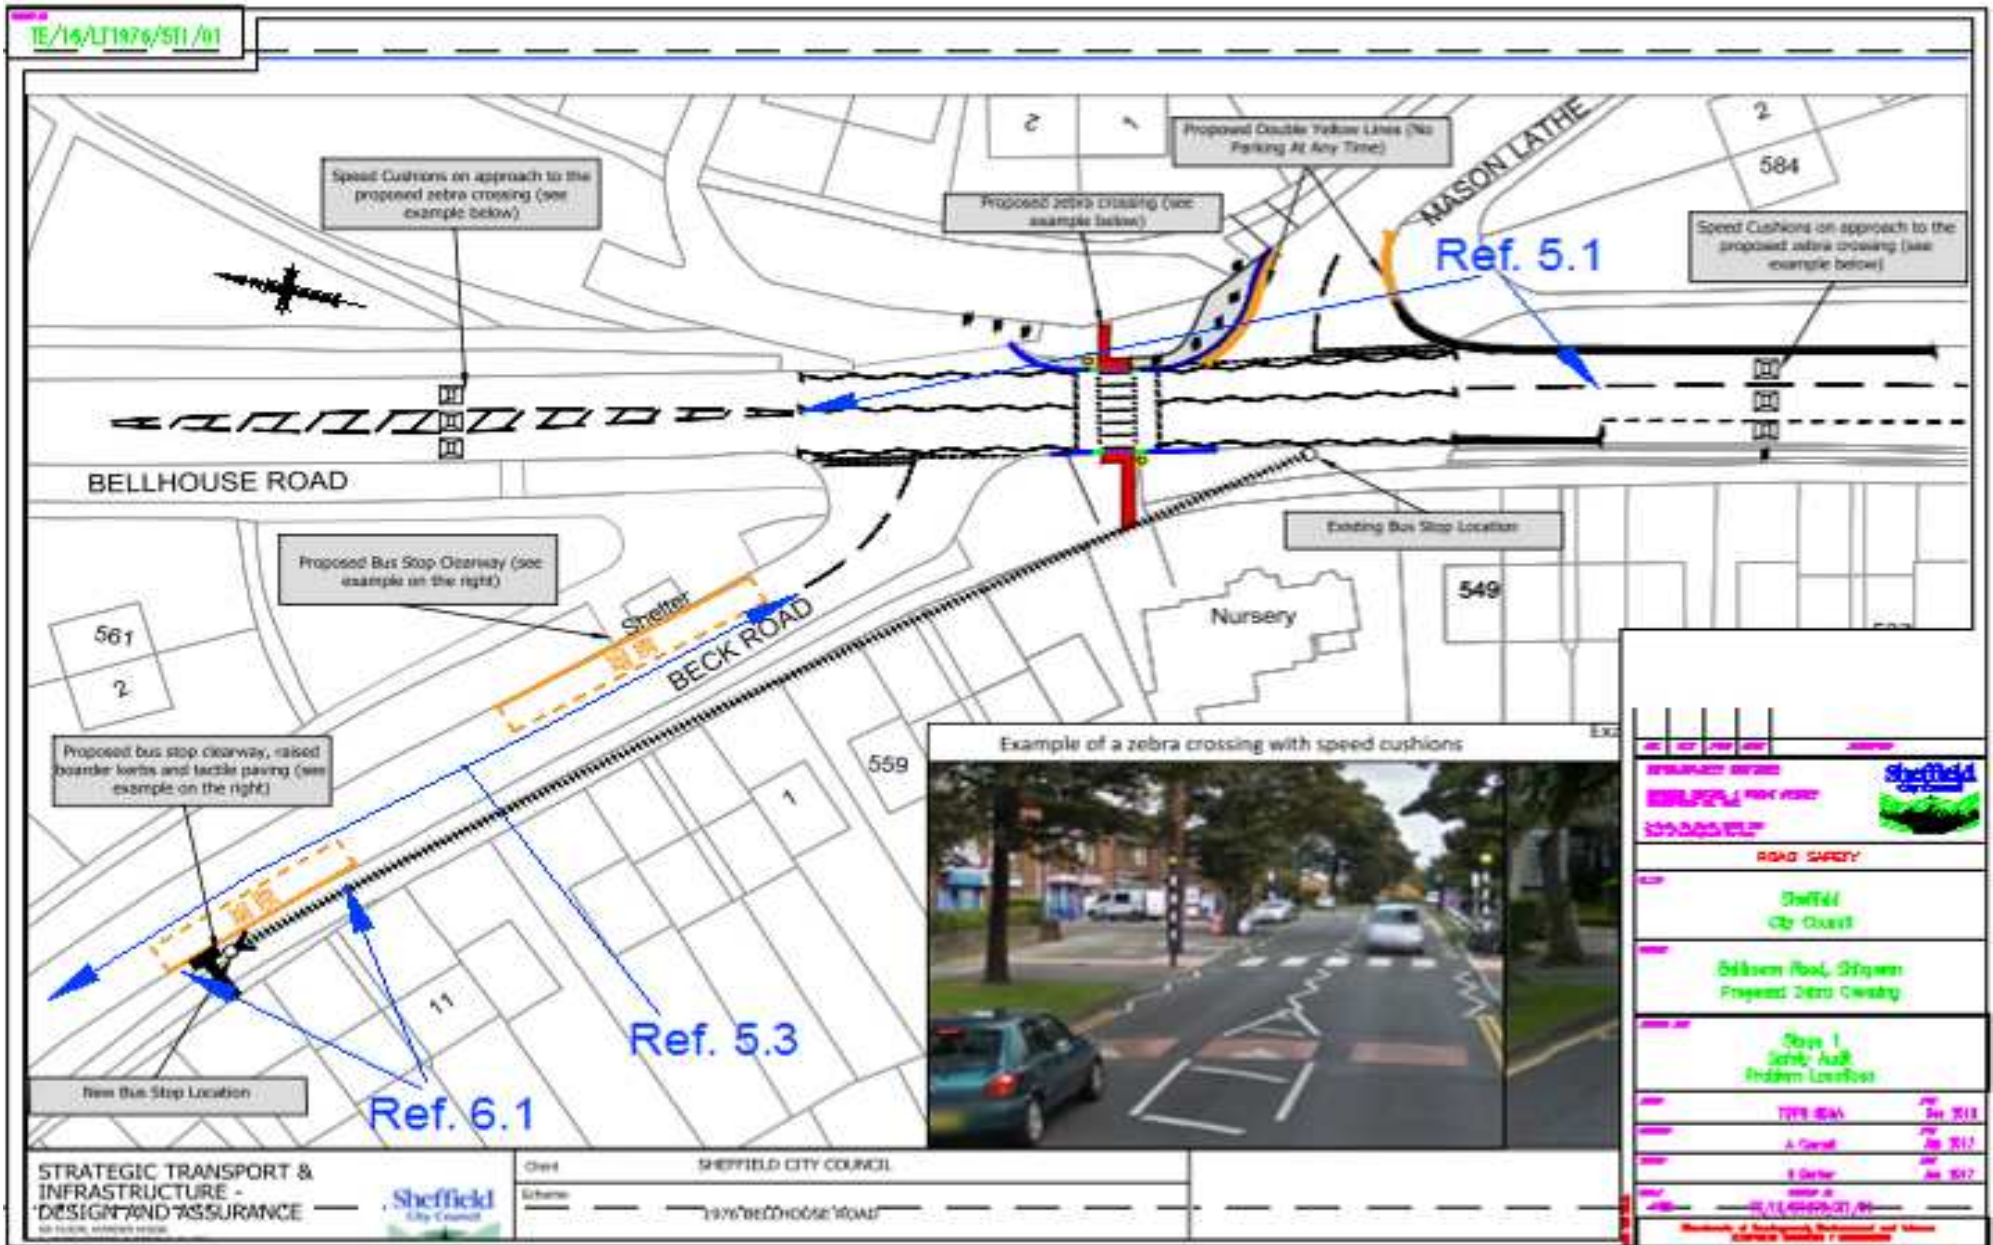
Location: Reference 5.1 on Plan TE/16/LT1976/ST1/01 at Appendix B – Bellhouse Road northbound approach to new crossing; right turn to Mason Lathe Road

Summary: Offset centreline may result in increased risk of pedestrian collisions on crossing, as detailed below

Location: Reference 5.3 on Plan TE/16/LT1976/ST1/01 at Appendix B – Beck Road over limits of carriageway bus-box markings

Summary: Lack of hazard warning line fails to inform drivers of potential hazard of buses manoeuvring, increasing collision risk

Location: Reference 6.1 on Plan TE/16/LT1976/ST1/01 at Appendix B – Beck Road northwest bound bus-stop
