CROOKESMOOR RD / BARBER RD CONTROLLED NMU FACILITIES

ROAD SAFETY AUDIT STAGE 1-2 [COMBINED PRELIMINARY & DETAILED DESIGN]

**DEVELOPMENT SERVICES
TRANSPORT, TRAFFIC & PARKING SERVICES – ROAD SAFETY**
Safety Audit Ref: TE/16-563/1796-LTP/ST1-2
Date: 13th February 2017

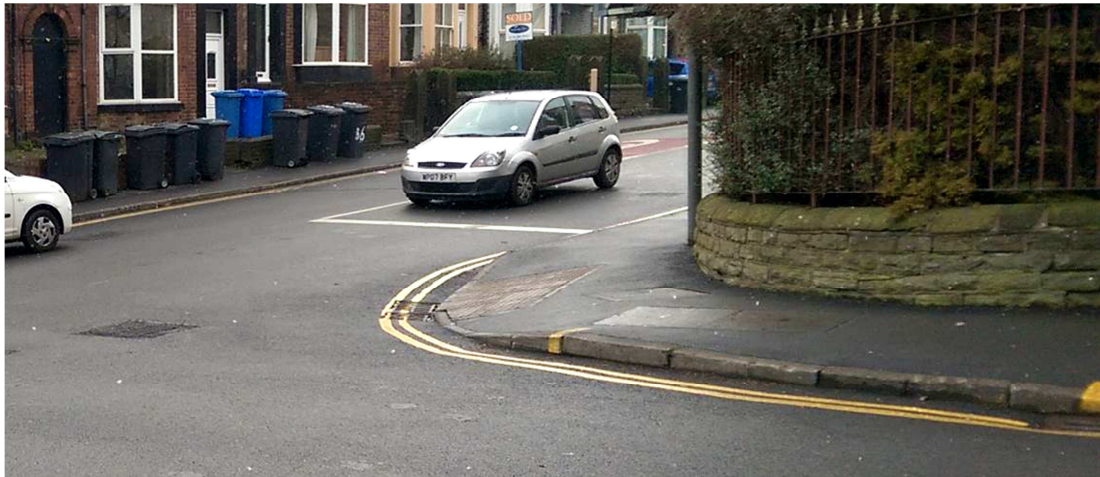
Location: Reference 5.2 on plan TE/16/1796-LTP/ST1-2/01 at Appendix B – Footway around eastern junction radius

Summary: Excessive fall across footway towards carriageway likely to result in pedestrian slips and falls towards adjacent live traffic lane

The vertical profile of the footway and adjacent carriageway around the junction radius in the above location is potentially dangerous. The carriageway is sunken where it abuts the kerb line, and in-turn the kerb line around the radius is very low (i.e. at the existing crossing point), resulting in an unacceptably steep gradient falling across the footway towards the carriageway edge. See photograph below;

Although the proposals include for relocation of this crossing, the provision of the full-height replacement kerb face would still leave an excessive footway gradient falling towards the carriageway.

This section of footway would still present a serious risk of slips of falls for pedestrians walking around the corner of the junction, particularly during or following inclement weather conditions (i.e. surface water and/or ice). The footway falls would be unlikely to meet Inclusive Mobility requirements even with a full height kerb face in-situ, and could be particularly hazardous for the elderly / mobility impaired.

The high footfall through here, the primary NMU safety intentions of the improvement, and the fact that the improvement proposes to remove and replace footway construction and kerbs around this radius, all suggest that SCC should address this obvious problem, albeit pre-existing. Necessary TTM and surfacing equipment / crew mobilisation required for the rest of the proposals should result in relatively low additional costs.

The proposed changes might actually increase the likelihood of slips here, despite a slightly reduced gradient. The existing blister paving will be removed, leaving a smooth tarmac surface with reduced grip.

Reconstruct the strip of carriageway abutting the junction radius over the limits of the existing depression, in order to lift the kerb line / gulleys at the front of the footway and so reduce footway falls.

The carriageway will not be constructed however the proposed kerb line at this location will have a 165mm upstand, the levels to the rear of the footway will also be also reduced (where practical), these two factors will reduce the severity of the cross fall.

Accepted.

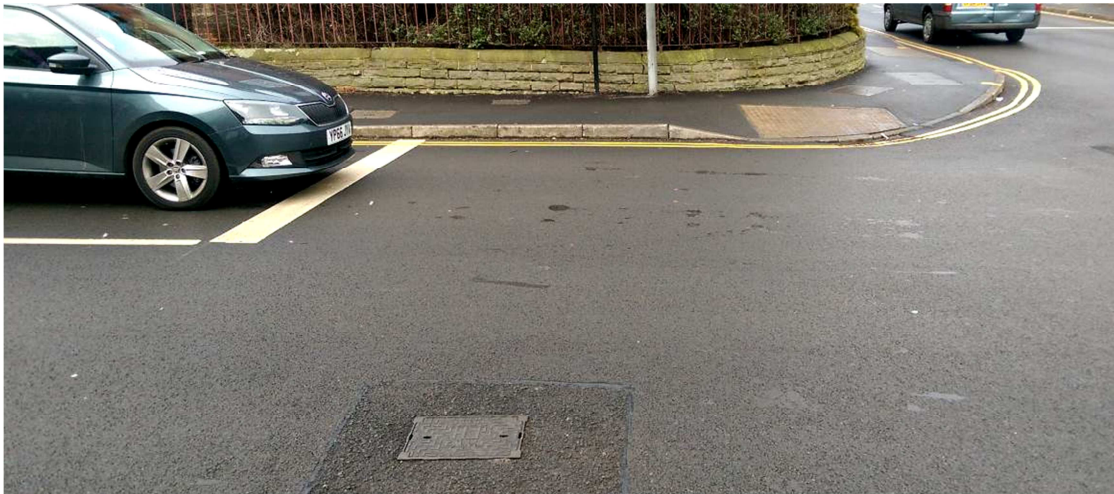
Location: Reference 5.3 on plan TE/16/1796-LTP/ST1-2/01 at Appendix B
– Proposed crossing of Crookesmoor Road western arm

Summary: Existing worn and polished ironwork cover in line of proposed NMU crossing results in risk of pedestrian slips and falls

The existing pedestrian crossing of the Crookesmoor Road western arm is to be relocated a short distance southwest of its current location. When this is done, an existing manhole would fall within the limits of the new controlled pedestrian crossing area. See photograph;

The ironwork cover is worn and polished, and there would be a likelihood of pedestrians slipping, falling and sustaining injury if stepping on the cover, particularly during or after inclement weather conditions.

Provide a non-slip cover to the manhole.

As this is a Yorkshire Water manhole cover it is not possible to replace it. No injury accidents have been recorded as a result of this in a ten year period.

Whilst less than ideal this is accepted, although given that pedestrians do not currently cross at this position the reference to a lack of injury accidents to date as a result of the manhole is considered irrelevant.

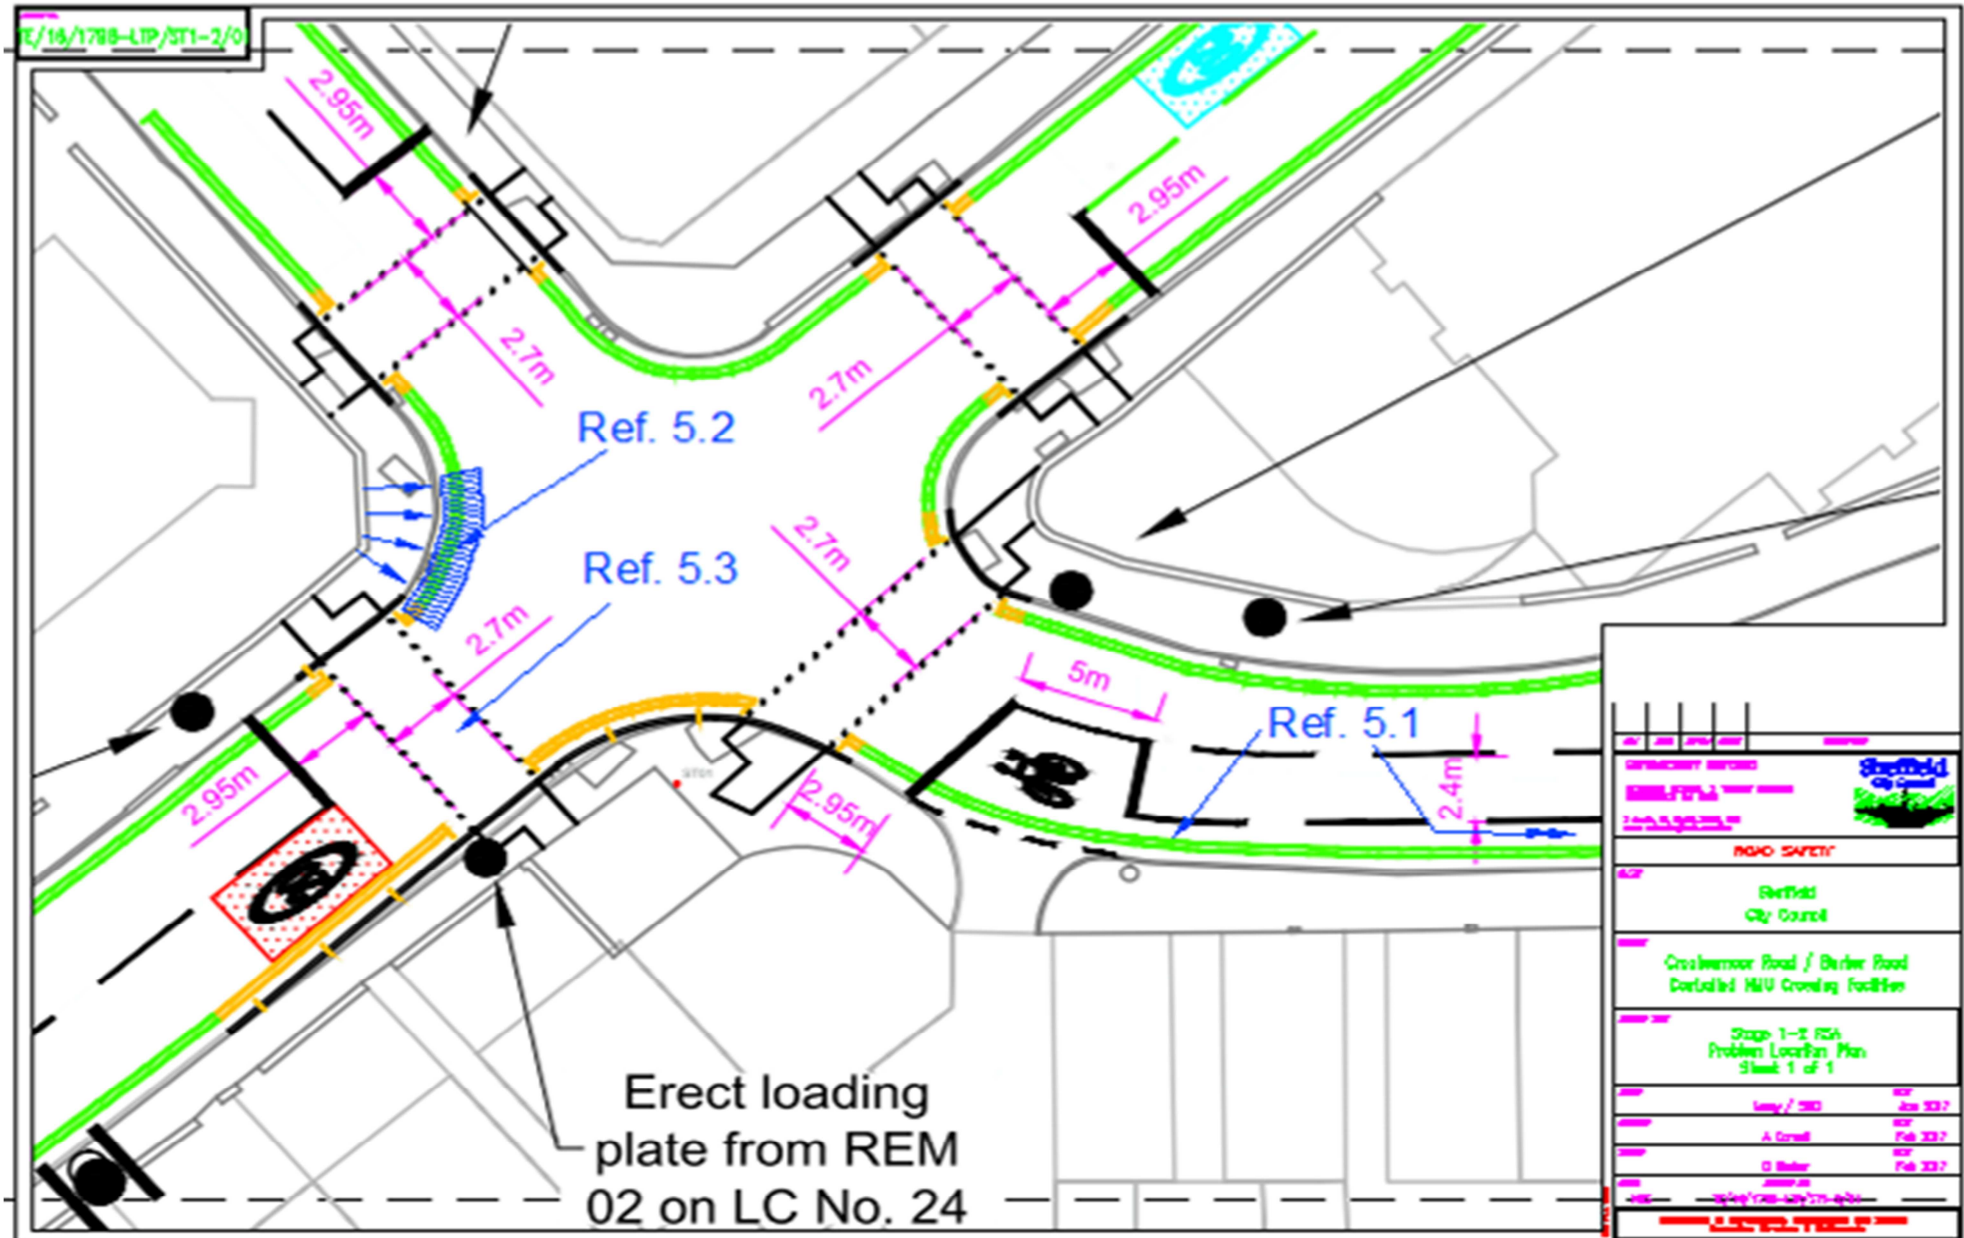
Location: Reference 5.1 on plan TE/16/1796-LTP/ST1-2/01 at Appendix B – Proposed Crookes Valley Road cycle lane feed-in to new ASL

Summary: Narrow widths of cycle lane and adjacent traffic lane combined with alignment likely to result in cyclists being struck by motor vehicles along junction approach

The proposed layout includes a new cycle lane running along Crookes Valley Road from Harcourt Road up to Crookesmoor Road / Barber Road crossroads, feeding into a new cycle ASL holding area at the junction stop-line. Whilst there are no dimensions indicated for the cycle lane, the adjacent traffic lane is as narrow as 2.4m in places. The cycle lane appears to be approximately 1.2m wide at best.

Crookes Valley Road is on a twisting horizontal alignment, comprising an ‘S’ bend along the section between the two junctions. Site observation of traffic movements suggests that motor vehicles would be unlikely to be able to negotiate the proposed layout without either repeatedly encroaching into the cycle lane, or encroaching into the opposing traffic lane. This would be particularly the case for buses, a number of which pass through the junction.

Cyclists would be at high risk of collisions from passing motor vehicles, or motor vehicles would be at risk of collisions with oncoming traffic when encroaching into the opposing lane to avoid cyclists.

For these reasons, the RSA Team do not consider that there is adequate width here to encourage cyclists to travel adjacent to motor traffic without compromising their safety. Cyclists should travel with traffic.

Remove the cycle lane from the proposals, but retain the ASL / holding area.

The Audit Team therefore considers that the cycle lane should commence just beyond the bend rather than just before it. Provided that the 1.5 metre width can be achieved this will maintain the benefits for cyclists whilst removing the dangers to them at the bend identified above.

Accepted - the cycle lane will be 1.5m and will start just beyond the bend.
