John Lewis Building Condition Assessment

Sheffield City Council

Summary Report

November 2021 Rev A

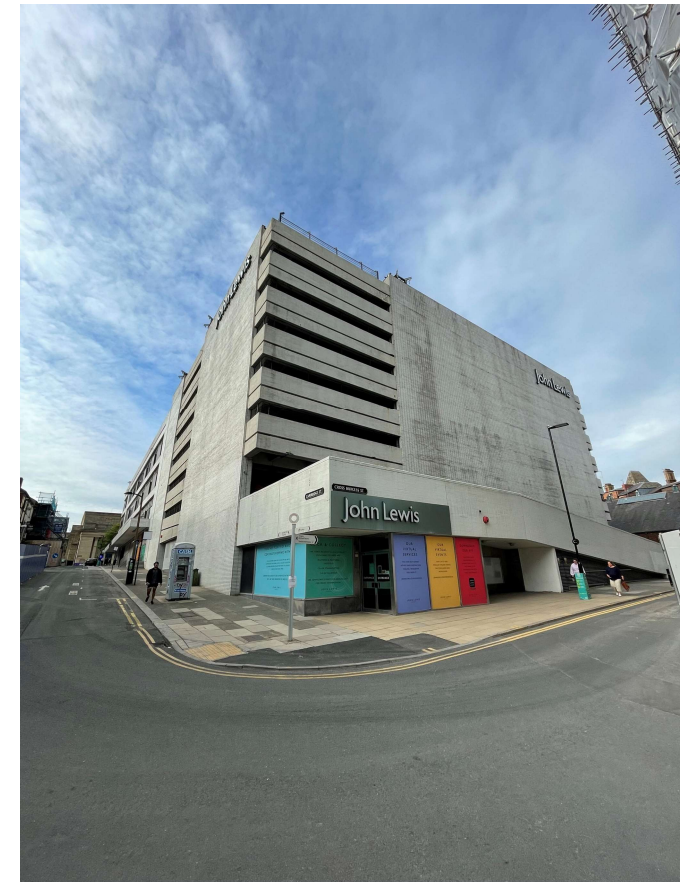
Assessing the building against current fire safety guidance highlights that the existing building contains significant shortfalls against the minimum provisions expected in a newer building.

Structural beams were observed to have cementitious/vermiculite type fire protection boards of varying thickness in the back of house and plant areas. It would be reasonable to assume that this would be likely to provide at least 60 minutes fire resistance. However, areas were observed where this protection was either damaged or missing.
